# Microvascular-based Hierarchical System for Sensing-Healing of Delamination in Composite Structures

Keywords: composite structure, self-healing, sensing, microvascular, optical fiber

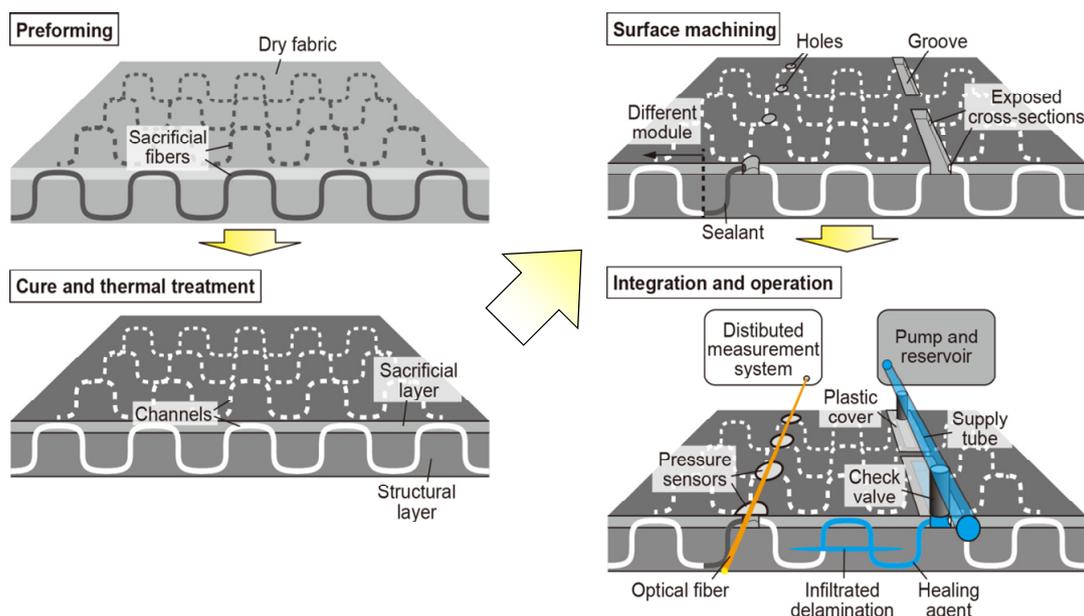
Figure 1: Overview of hierarchical system for autonomous sensing and healing.

The authors' research group recently proposed an autonomous sensing-healing system applicable to large-scale composite structures (Fig. 1, [1]). First, sacrificial fibers (catalyst-impregnated polylactide (PLA) fibers, [2]) are woven into a dry fabric. After resin infusion and curing, the sacrificial fibers are removed by heating the panel to vaporize the PLA, which yields empty channels in the panel. Cross-sections of these empty channels are then exposed to the panel surface. The panel has a surface sacrificial layer, which does not bear a load, and the channels partially go

through the sacrificial layer. By slightly machining the panel surface, one can expose the cross-sections of the necessary channels without damaging the structural layer. Channels are then connected to the main supply tube of a pressurized healing agent through check valves. Meanwhile, shallow holes are created on the other side of the channels, and fiber-optic-based pressure sensors are installed on them. When delamination occurs, the healing agent flows into the channels breached by the delamination and infiltrates the damage for healing. At the same time, the pressure sensors identify the damaged channels by detecting the internal pressure changes. Our previous paper validated the proposed system through detection and infiltration of damage [1]. This study presents the actual healing of a carbon/epoxy stiffened panel. This is, to the best of the authors' knowledge, the first attempt to demonstrate a sensing-healing system in a practical structural element.

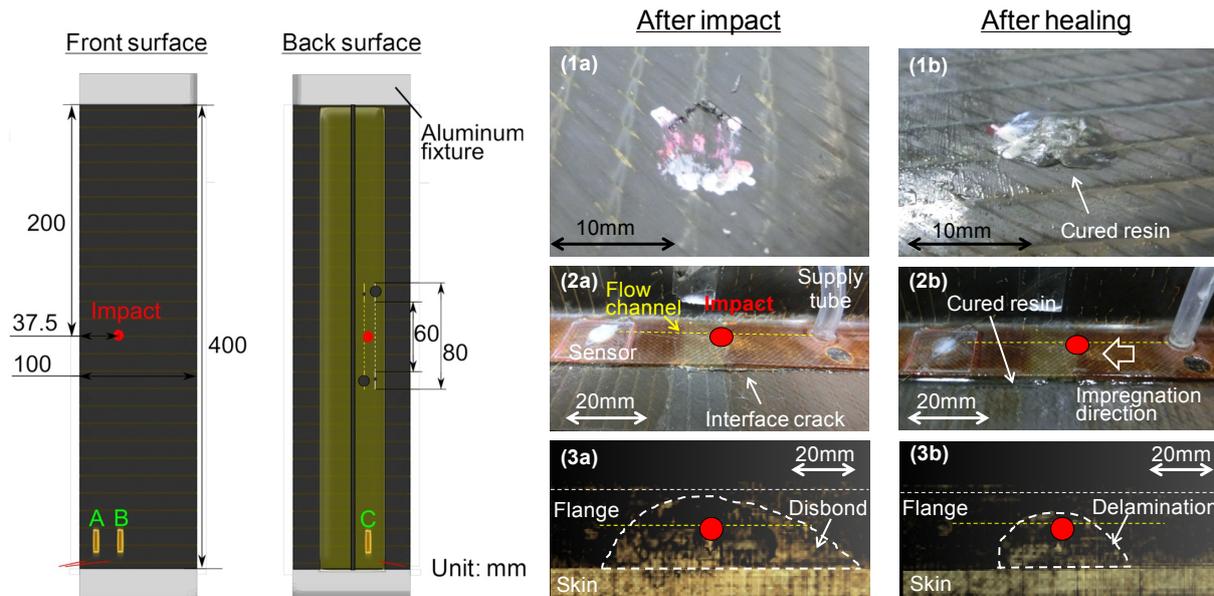
Figure 2: CAI specimen (left) and comparison of damage states (right).

Figure 2 (left) depicts the schematic of the composite stiffened panel. The panel was manufactured using vacuum-assisted resin transfer molding (VaRTM) and composed of a T-shaped stiffener and a skin. Aluminum jigs were attached to both edges of the specimen to apply compressive loading. The materials used were non-crimp fabrics (SAERTEX GmbH & Co.) of aerospace-grade carbon fibers (Toray Industries, Inc., T800S) and an epoxy resin (XNR6813K/XNH6813K, Nagase ChemteX Co.). Stacking sequence of the skin and the stiffener was quasi-isotropic  $[-45/+45/0/90]_{2S}$ , and additional plies of plain-woven dry glass fabrics (M200×104H3, Unitika, Ltd.,  $[-45, 45]_3$ ) were laid on the surface of each stiffener flange as the sacrificial layer. Two chemically-treated PLA fibers (Unitika, Ltd., 200  $\mu\text{m}$  diameter, 80 mm length) were woven into the stiffener flange in the longitudinal direction. After the cure and heat treatment to vaporize the PLA, flow channels were formed in the interface between the stiffener and the skin. Both edges of the flow channels were positioned within the sacrificial layer and four shallow holes were formed on the surface using a milling machine to expose the cross-section of the embedded channels (Figs. 2 (left)). In the following test, only the channel close to the center of the stiffener was used. The smaller hole (2 mm diameter, 0.8 mm depth) was connected with the supply tube for the healing agent. Room-temperature curing, ultra-low-viscosity epoxy resin (E205, Konishi Co.,Ltd, 100  $\text{mPa}\cdot\text{s}$  at 20°C) was selected for the resin, after considering diameter of the embedded flow channel (200  $\mu\text{m}$ ), the mechanical property, and the practical healing condition. And the larger hole (8 mm diameter, 0.9 mm depth) was covered with a square acrylic substrate (20 mm side length, 1 mm thickness) and a fiber Bragg sensor was bonded on the plastic cover.

After the flow channel was filled with compressed air of 0.1 MPa gauge pressure, impact energy of 25 J was applied to the center of the flange width (Fig. 2 (left)). The strain dropped immediately after the disbond induced by the impact breached the flow channel, successfully detecting the damage. After the impact test, both surfaces of the specimen were visually checked. At the impact point (Fig. 2 (1a)), there was a small surface dent with depth of 0.3 mm and thus the damage introduced was barely visible impact damage (BVID). Furthermore, a long interface crack (80 mm length) was seen between the stiffener flange and the skin (Fig. 2 (2a)), implying that large disbond was introduced in the interface between the skin and the stiffener. Fig. 2

(3a) presents a photograph of the internal damage observed by an ultrasonic inspection system. A semicircular disbond reaching the channel position was observed, indicating that flow channel was successfully breached by the disbond.

The damaged panel was then healed by injecting the healing agent. The injection was stopped when the gap (i.e., crack) between the flange and the skin was filled with the healing agent (visually checked). The healing agent was cured at room temperature for 24 h under atmospheric pressure. Figures 2 (1b) and (2b) present photographs of the specimen after healing. The gap between the flange and the skin was successfully closed with the resin (Fig. 2 (2b)). Furthermore, a cured resin was observed in the residual dent on the impacted surface (Fig. 2 (1b)), indicating that the resin injected from the back surface flowed in the through-thickness direction and finally reached the opposite surface. Figure 2 (3b) presents the result of the ultrasonic inspection. The disbond disappeared, and the delaminated area in the skin decreased. Even though perfect infiltration of the damage including the skin delamination was not achieved, the hierarchical system demonstrated its high performance to infuse large damage in practical structures.

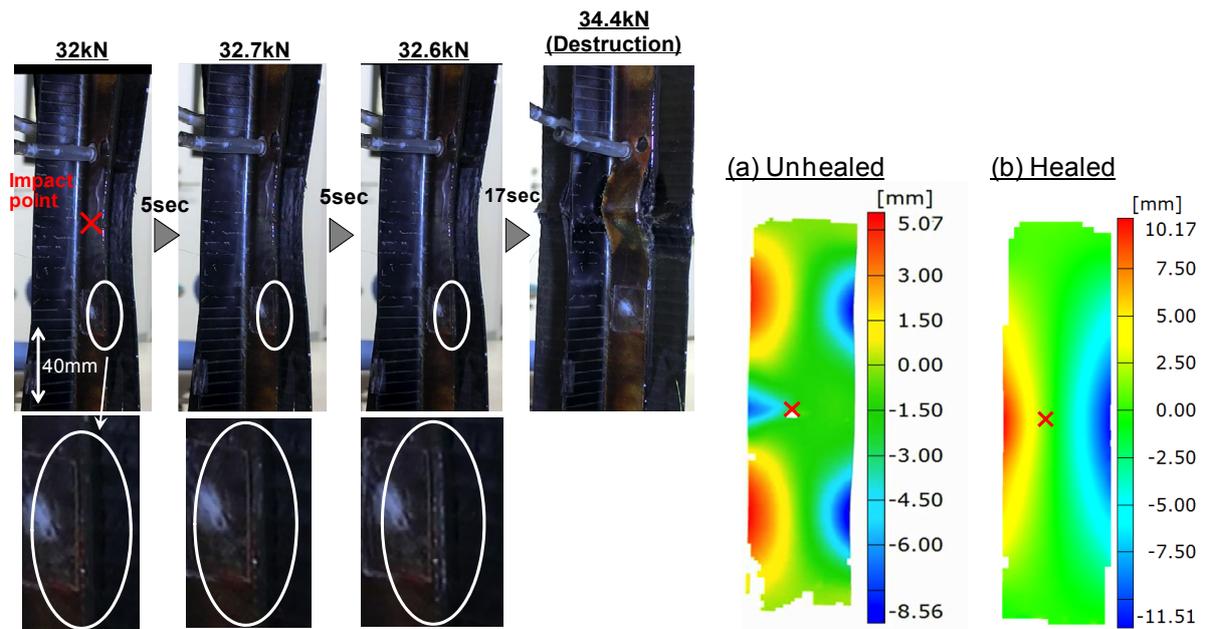
Figure 3: Photographs of healed flange (left) and comparison of deformation (right).

Finally a compression test was performed using a material testing system (AG-50kN, Shimadzu Co.). The panel began to globally buckle at 19 kN and the buckling mode changed to a one half-wave mode at 23 kN. The load then increased while keeping the same buckling mode. However, the load suddenly dropped at 32.7 kN, and the panel failed at 34.41 kN. Figure 3 (left) presents photographs of the healed flange under compressive loading. At 32.7 kN, an interface crack occurred between the skin and the flange from the edge of the healed disbond (Fig. 2 (2b)), resulting in localization of the buckling deformation. The healed region lost the structural support from the stiffener and the final failure occurred. Preliminary tests confirmed that equivalent stiffened panels with and without damage had the strength of 26 kN and 43 kN, so the strength partially recovered by healing but the full recovery could not be achieved. This may be attributed to two reasons. One is that the healing agent utilized was weak and/or incompatible with the host resin. A more appropriate resin would be needed to fully recover the strength. Second reason is the resin impregnation direction. The healing agent flowed into the disbond from the breach

point of the channel nearest to the supply tube (Fig. 2 (2b)), thus the impregnation speed and pressure of the resin was significantly low at the pressure sensor side, where the interfacial crack occurred. Consequently, small non-impregnated area (i.e., origin of crack) might be generated even though ultrasonic inspection couldn't detect it (Fig. 2 (3b)). This implies the necessity to design more complex channel network to fully infuse complex damage in practical structures.
